Evaluating the Use of Drones for Timber Bridge Inspection

Junwon Seo
James P. Wacker
Luis Duque

Forest Service
Forest Products Laboratory
General Technical Report
FPL-GTR-258
August 2018

A FHWA-NHCBP (National Historic Covered Bridge Program) publication

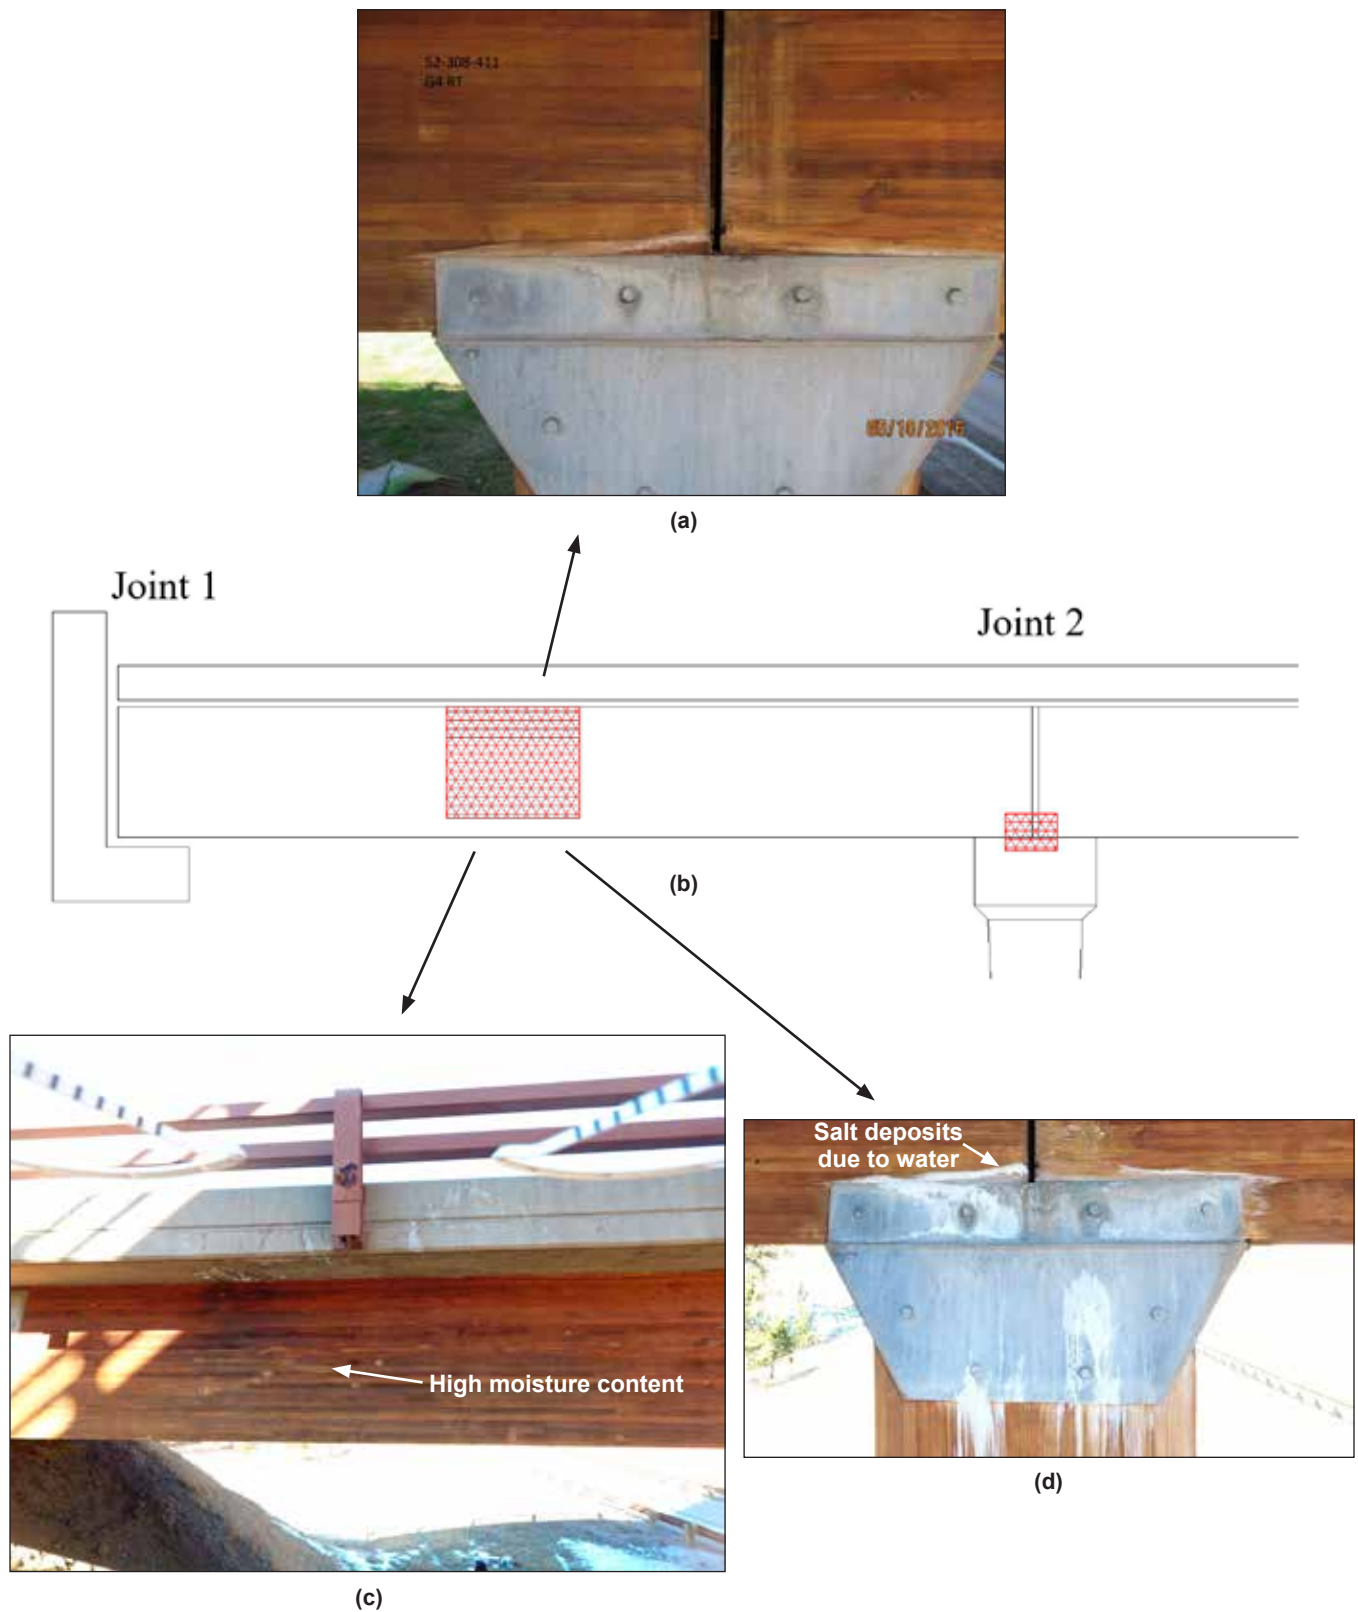
Figure 59. Sample damage on girder: (a) reference image taken during conventional inspection (used with permission from South Dakota Department of Transportation); (b) damage location; (c) some moisture on the side of Girder 4 between Joints 1 and 2; (d) salt deposits caused by water coming from deck at support of Girder 4 at Joint 2.

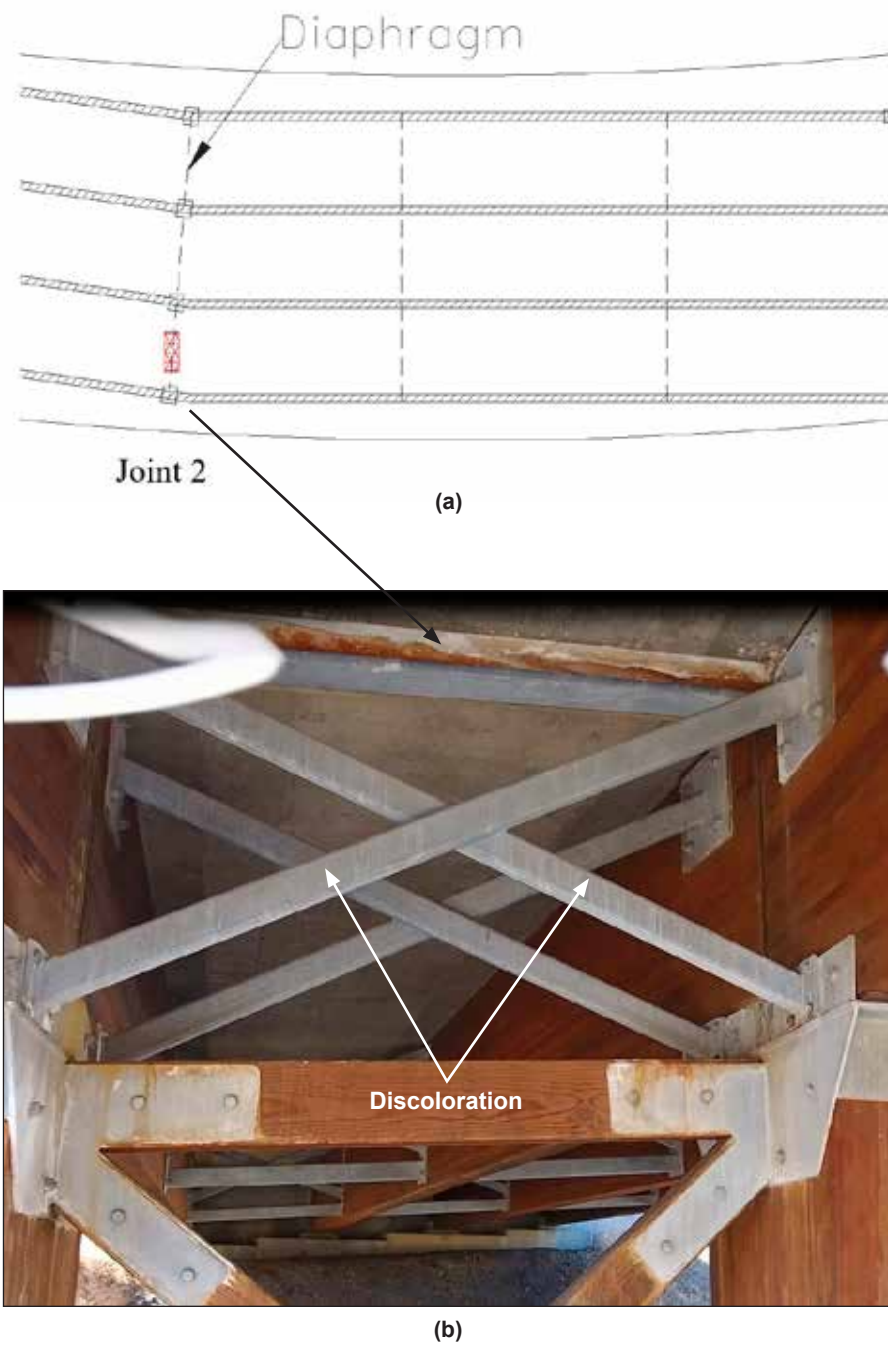
Figure 60. Sample damage on diaphragm: (a) damage location; (b) discoloration of diaphragm at Joint 2.

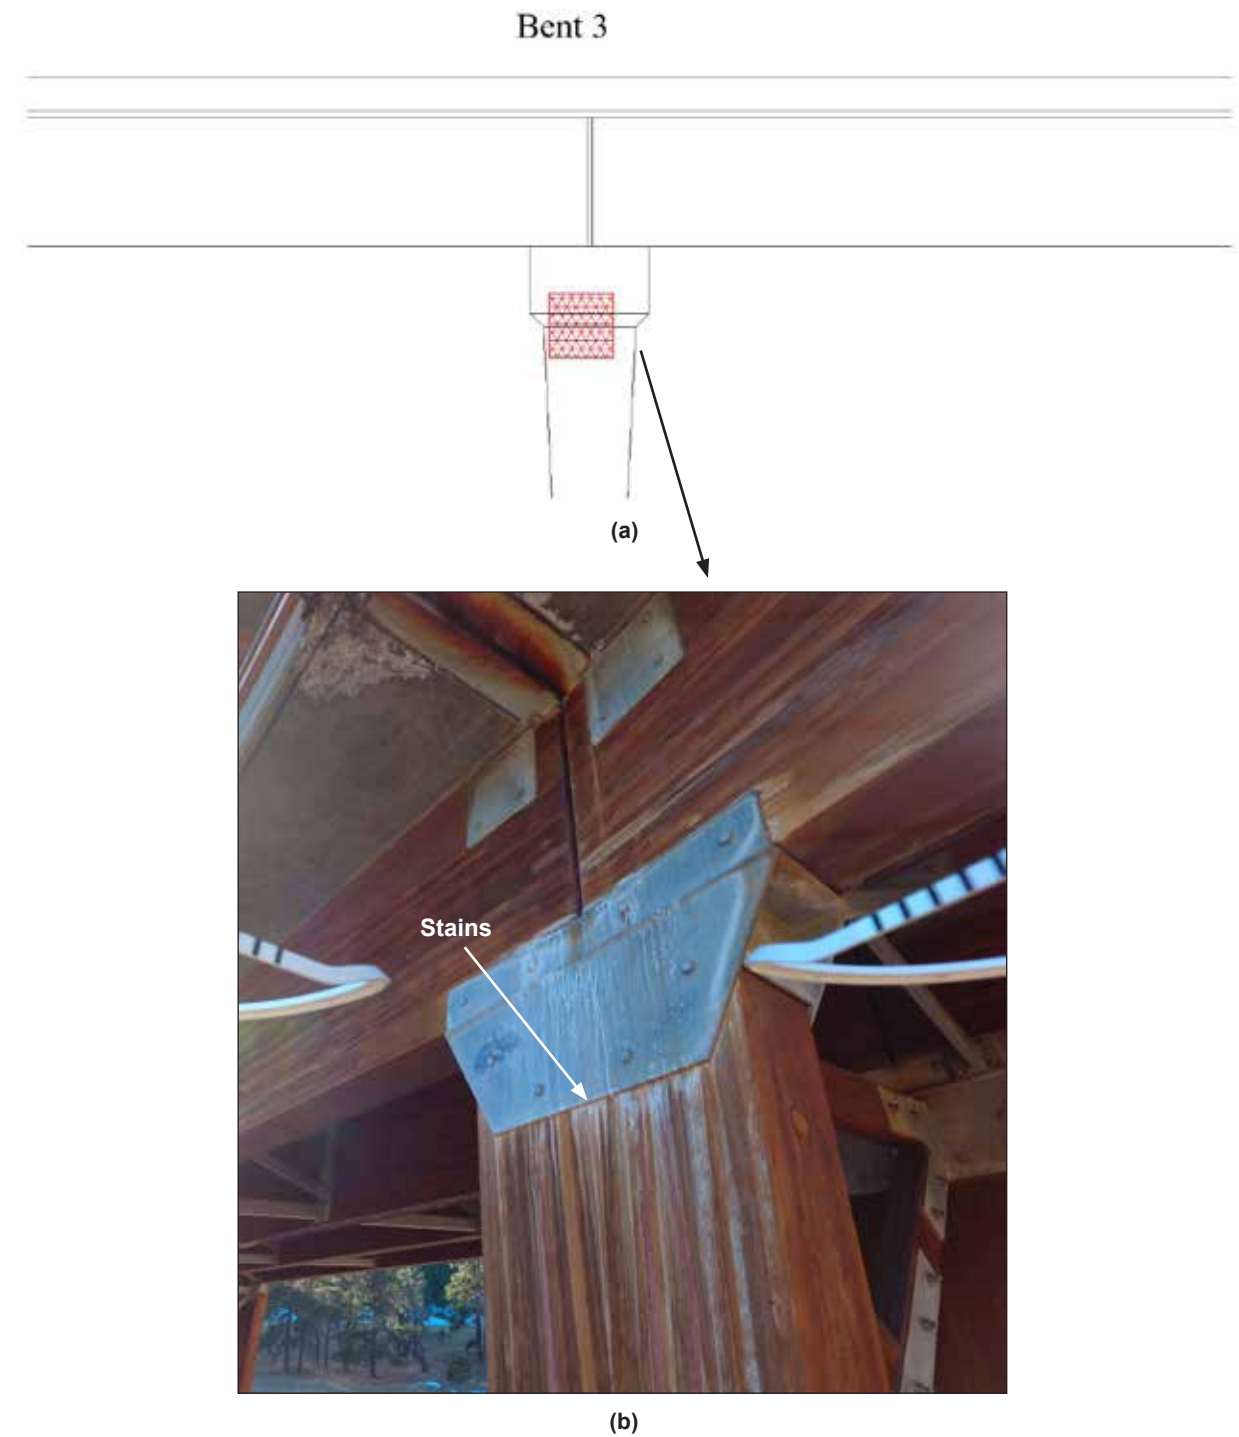
Figure 61. Sample column damage: (a) damage location; (b) stains on top of Column 4 at Bent 3.

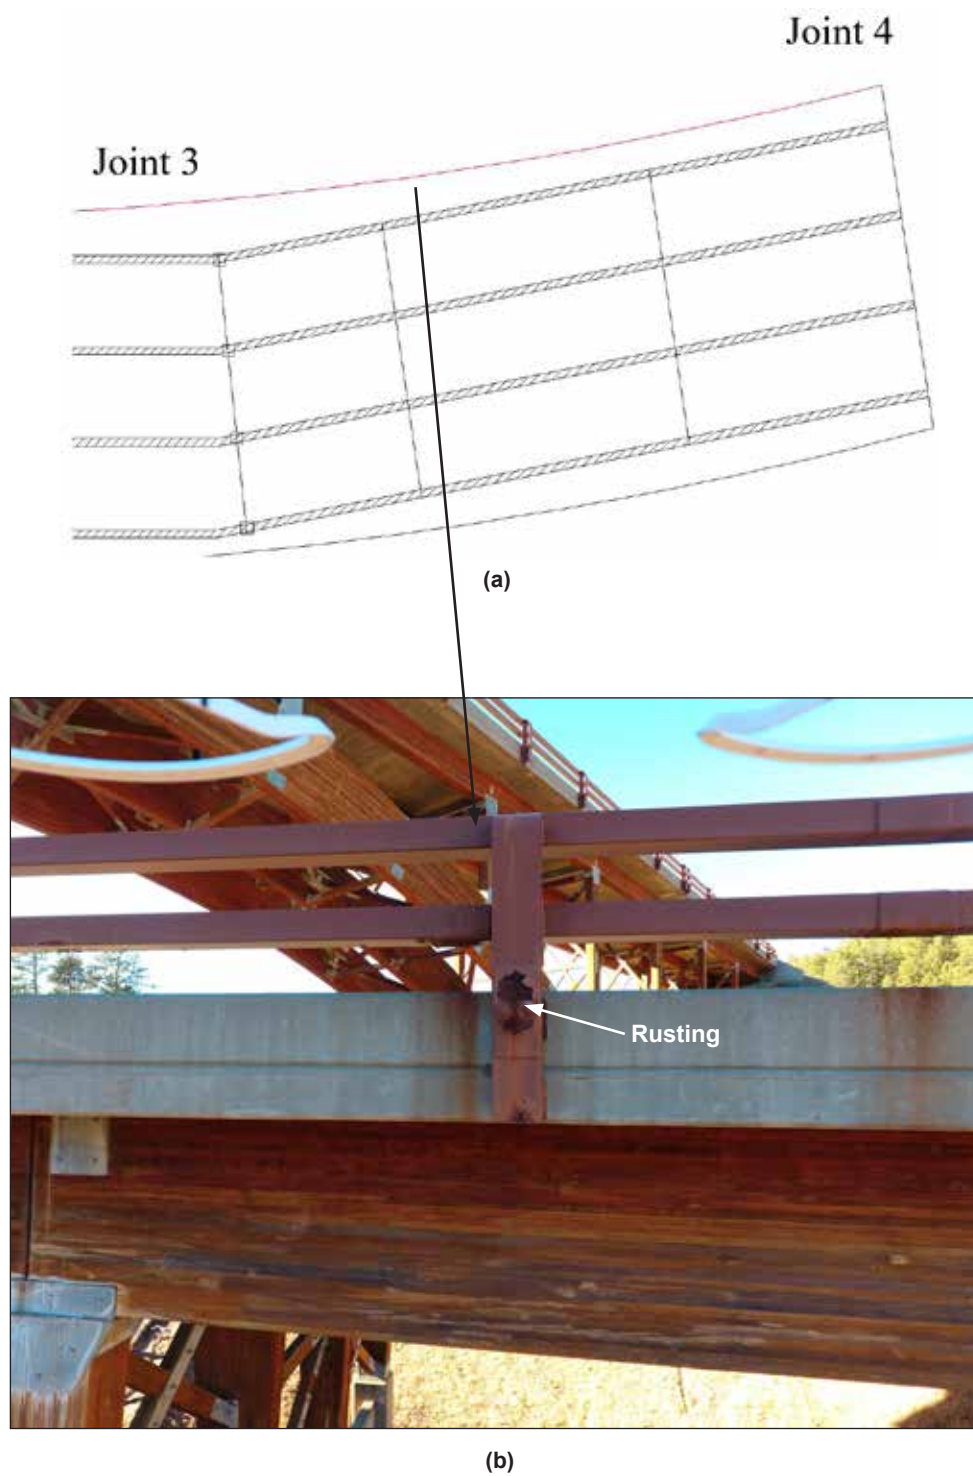
Figure 62. Sample damage on railing: (a) damage location; (b) rusting between Joints 3 and 4 near Girder 4.

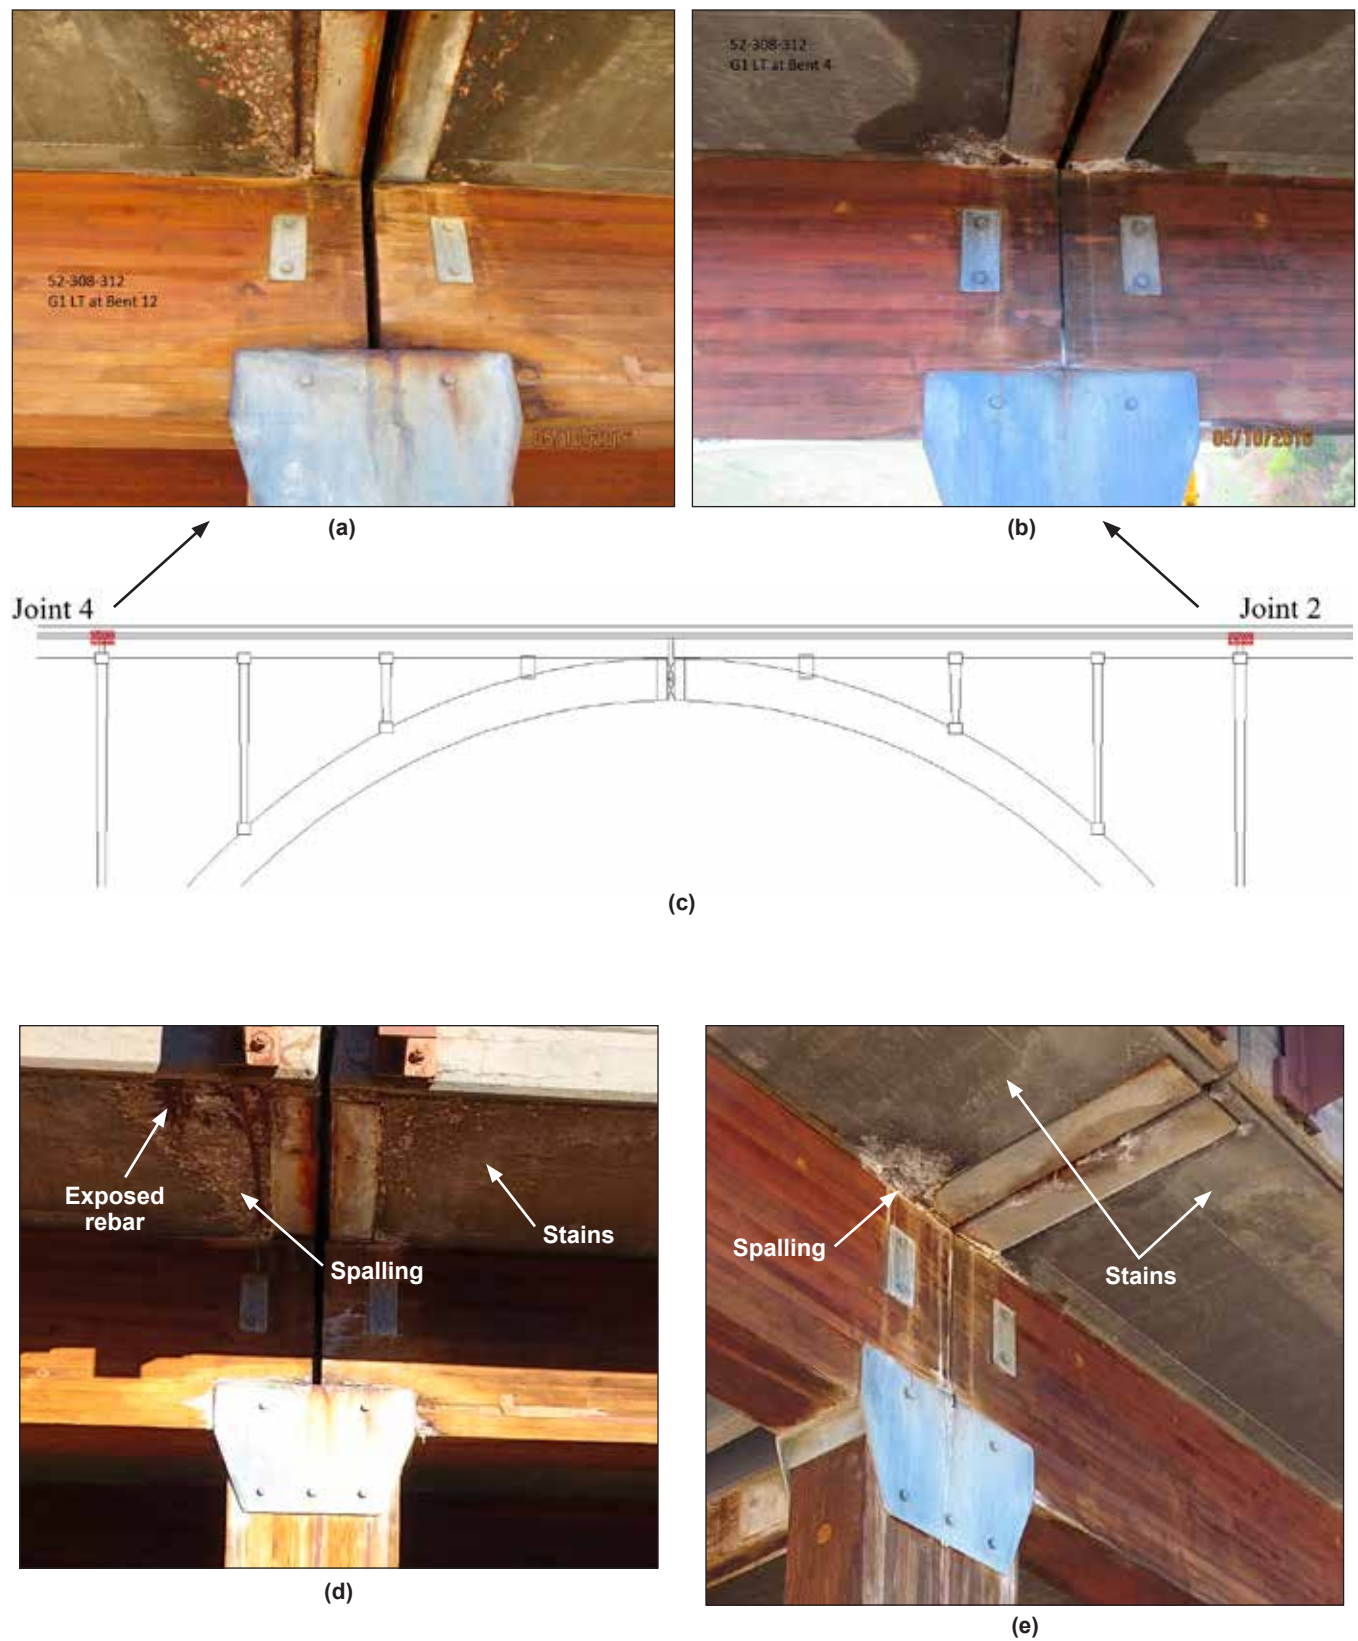
Figure 64. Sample damage on deck at Joints 2 and 4 on Stringer 1: (a) reference image of Joint 4 taken during conventional inspection (used with permission from South Dakota Department of Transportation (SDDOT)); (b) reference image of Joint 2 taken during conventional inspection (used with permission from SDDOT); (c) damage location; (d) concrete spalling, stains, and exposed corroded rebar near Stringer 1 at Joint 4; (e) concrete spalling and stains near Stringer 1 at Joint 2.

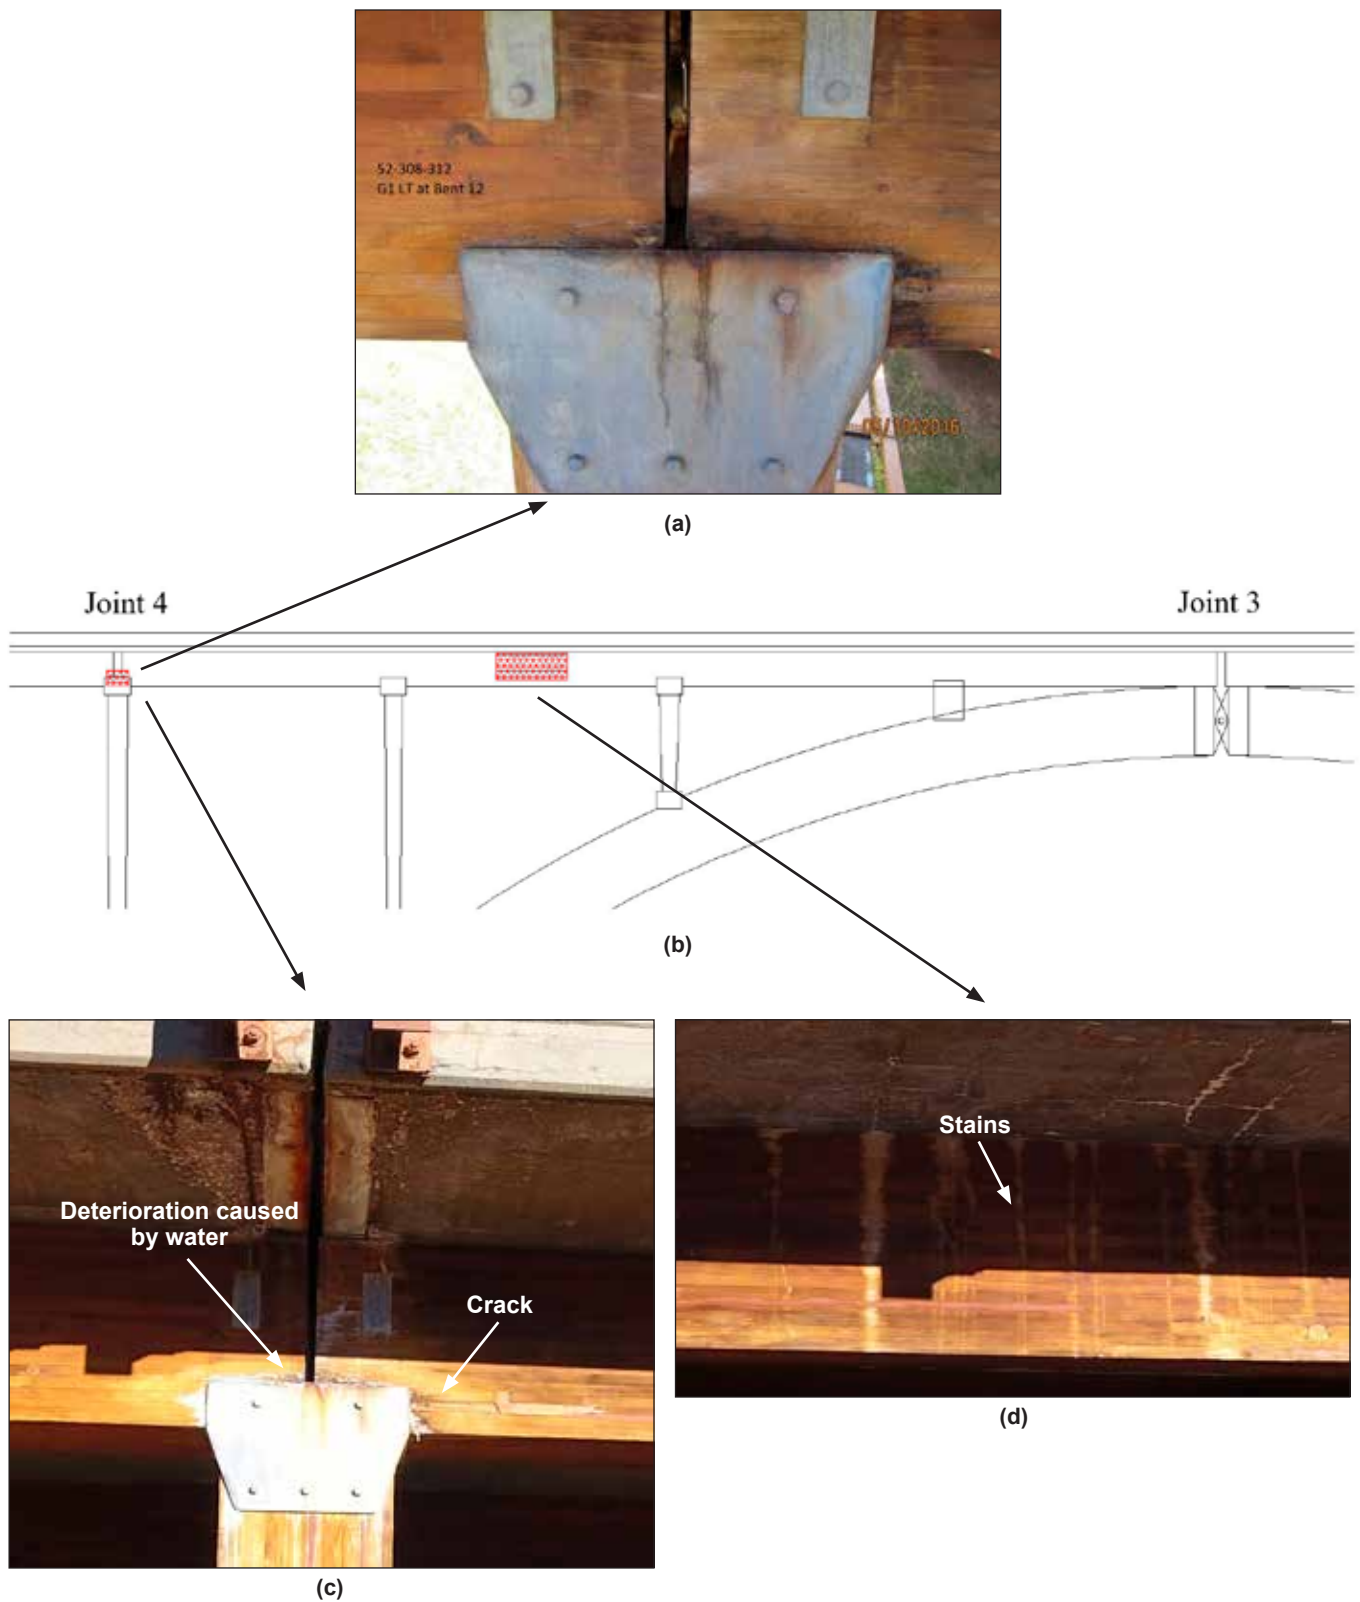
Figure 66. Sample damage on Stringer 1: (a) reference image taken during conventional inspection (used with permission from South Dakota Department of Transportation); (b) damage location; (c) shear crack and deterioration caused by water on Stringer 1 at Joint 4; (d) stains on Stringer 1 between Joints 3 and 4.

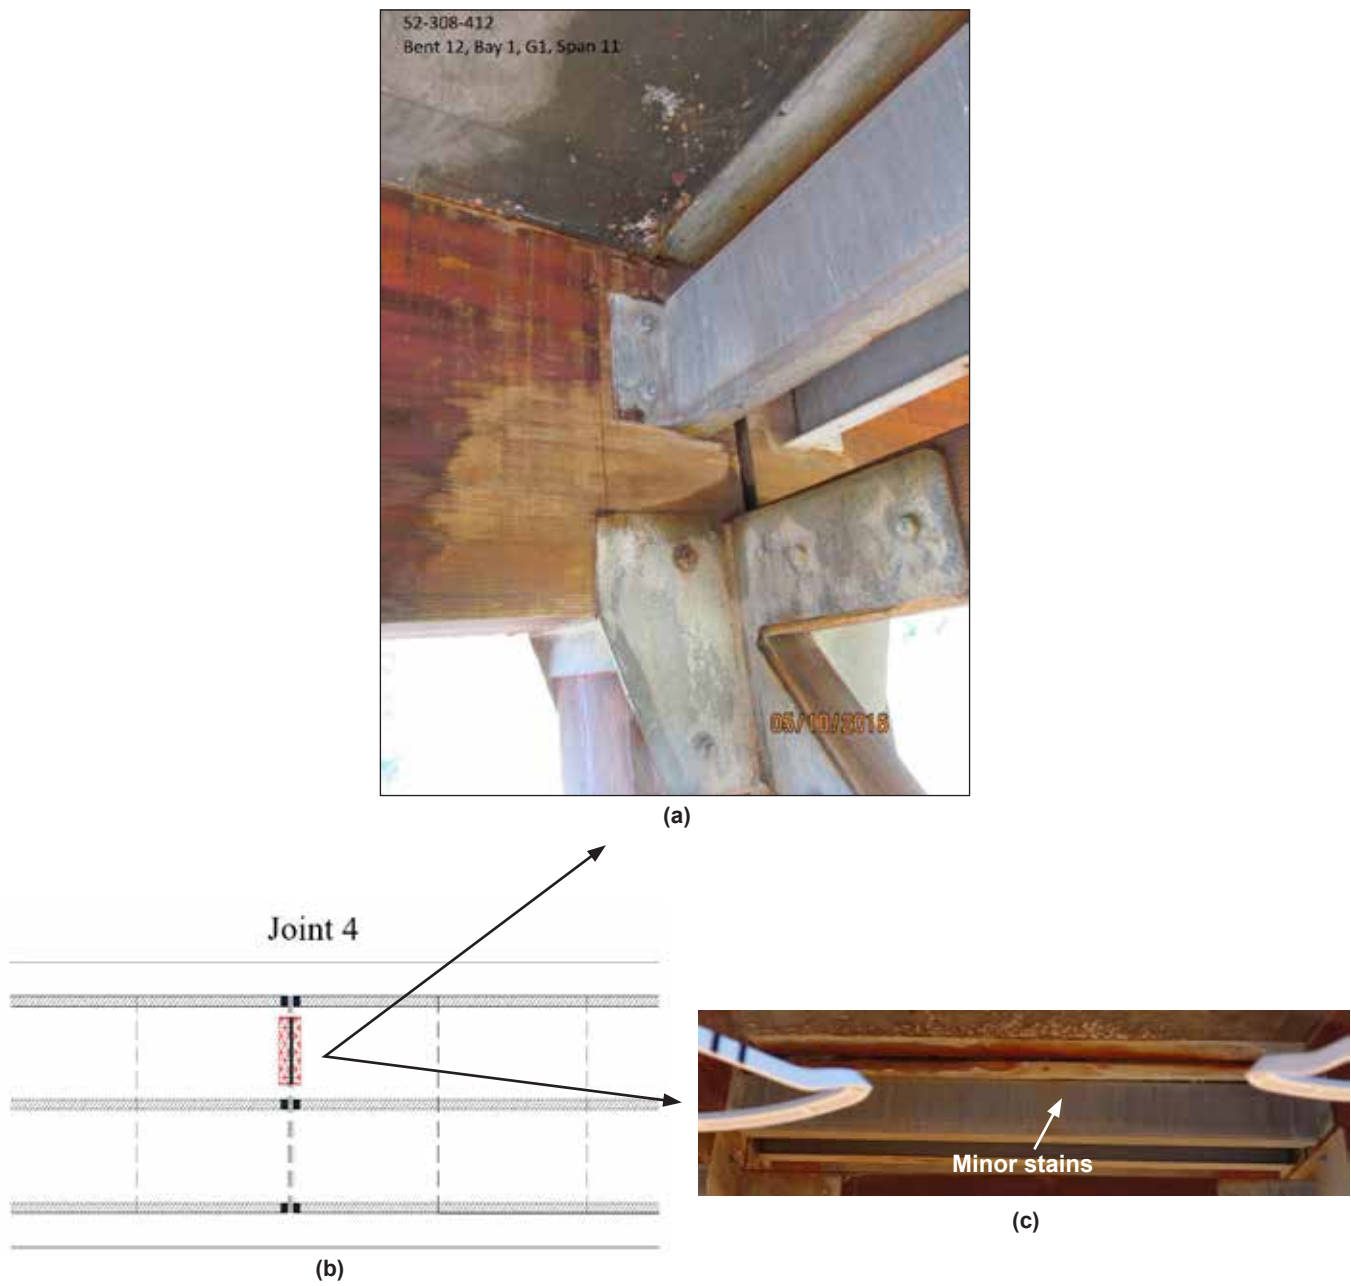
Figure 67. Sample damage on diaphragm at Joint 4: (a) reference image taken during conventional inspection (used with permission from South Dakota Department of Transportation); (b) damage location; (c) minor stains on diaphragm on Bay 1 at Joint 4.

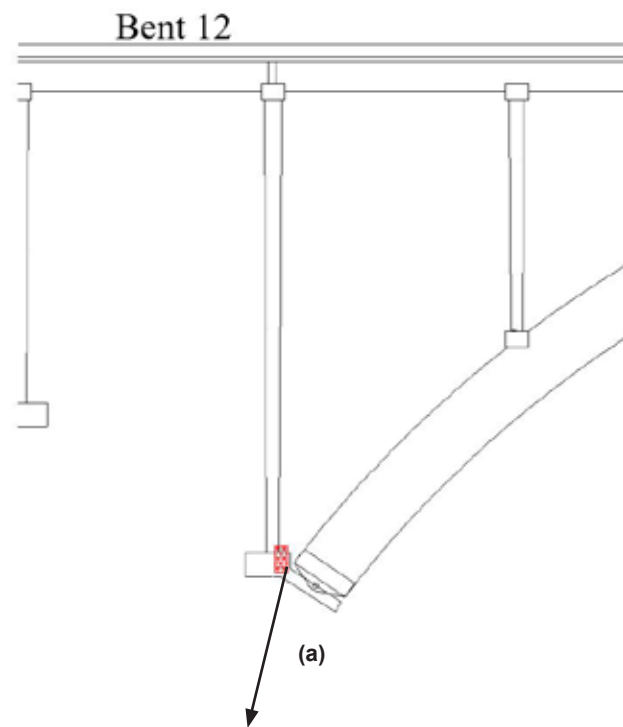
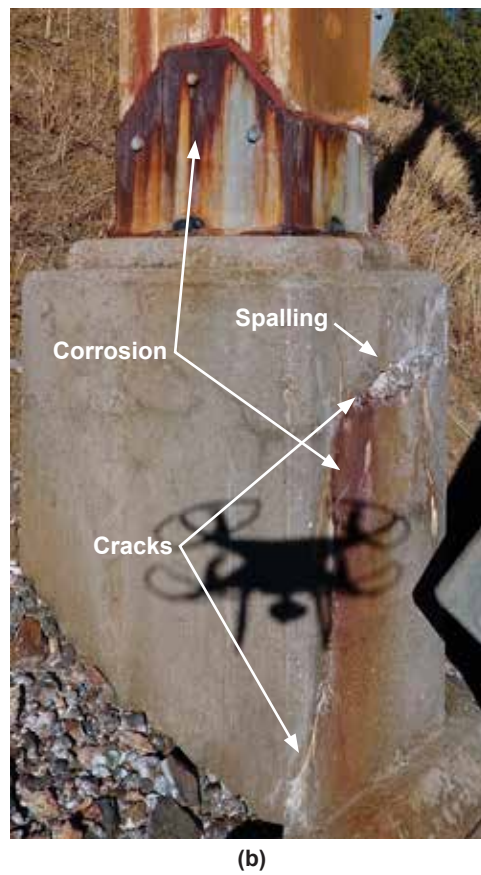
Fig. 68. Sample damage on Column 1 at Bent 12: (a) schematic of bridge; (b) concrete cracks, spalling, and corrosion on Column 1 Pedestal at Bent 12.

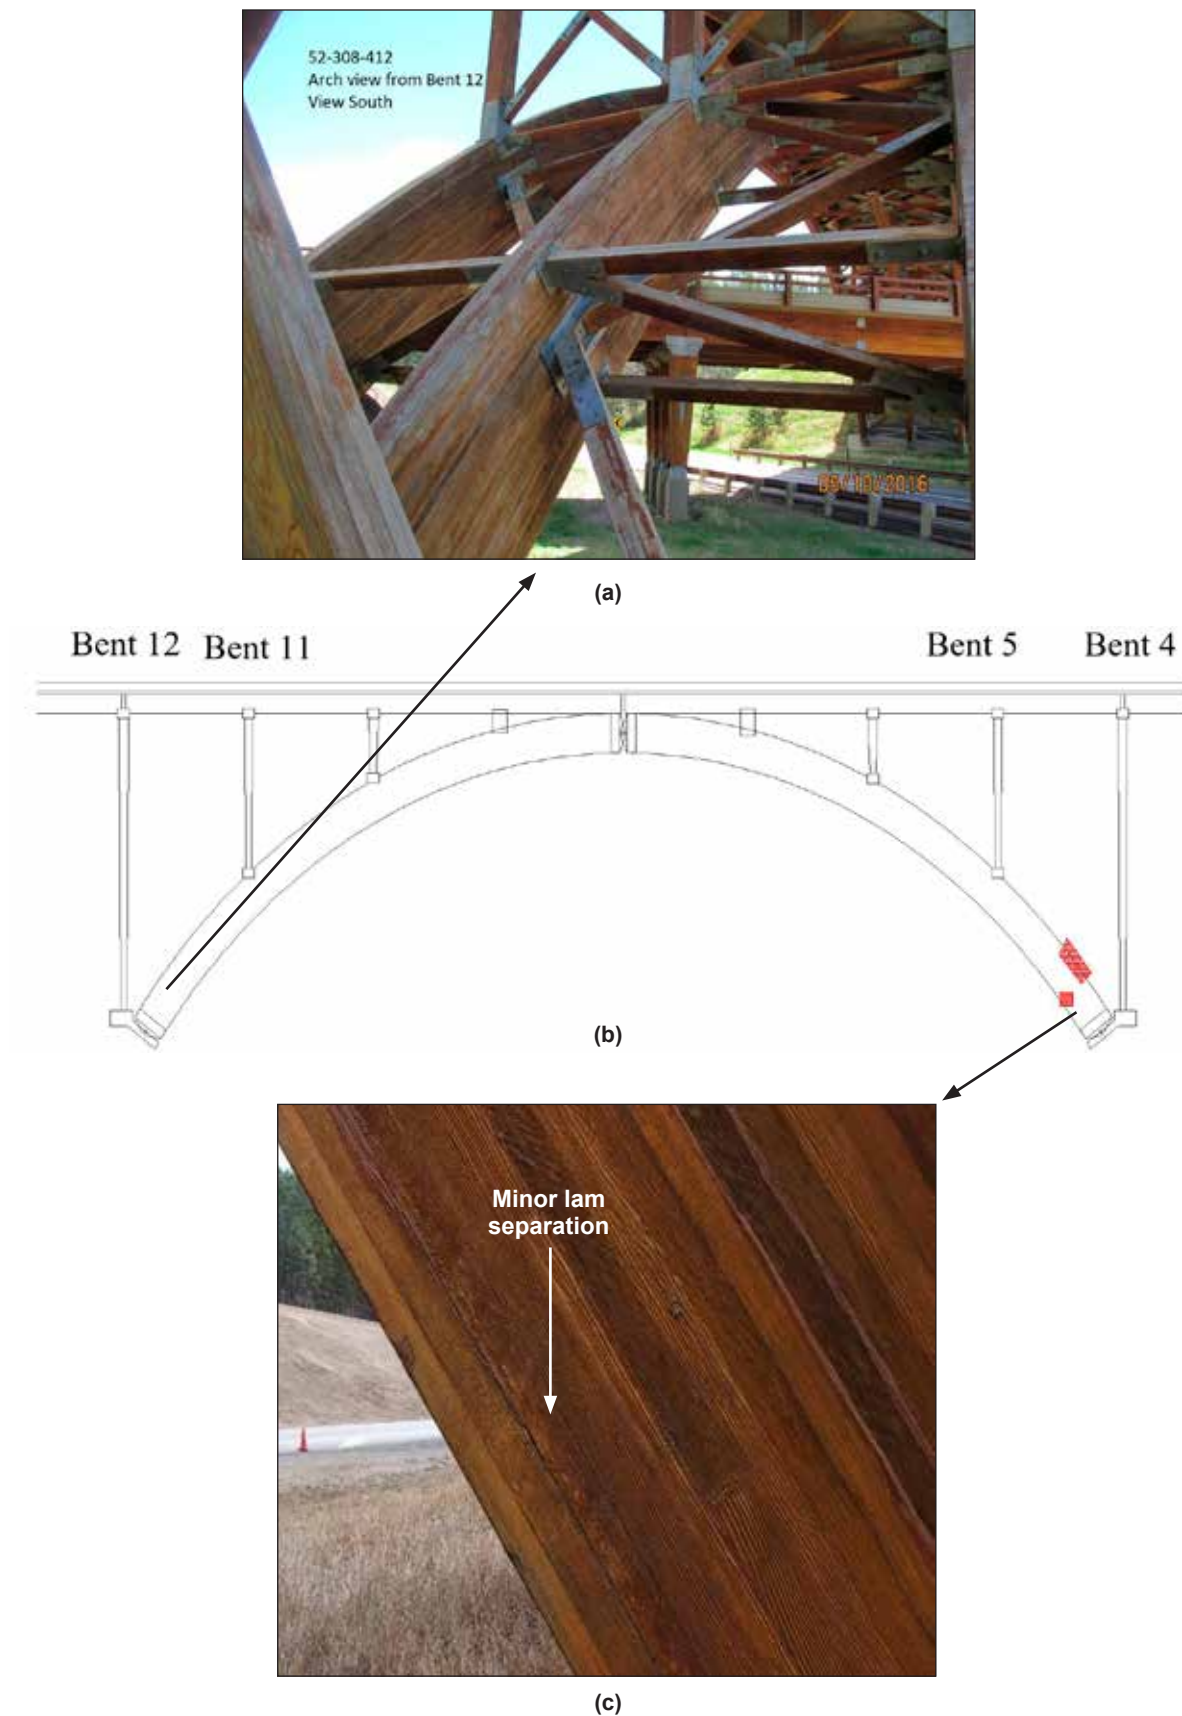
Figure 69. Sample damage on Arch 1: (a) reference image taken during conventional inspection (used with permission from South Dakota Department of Transportation); (b) damage location; (c) minor lam separation on Arch 1 between Bents 4 and 5.

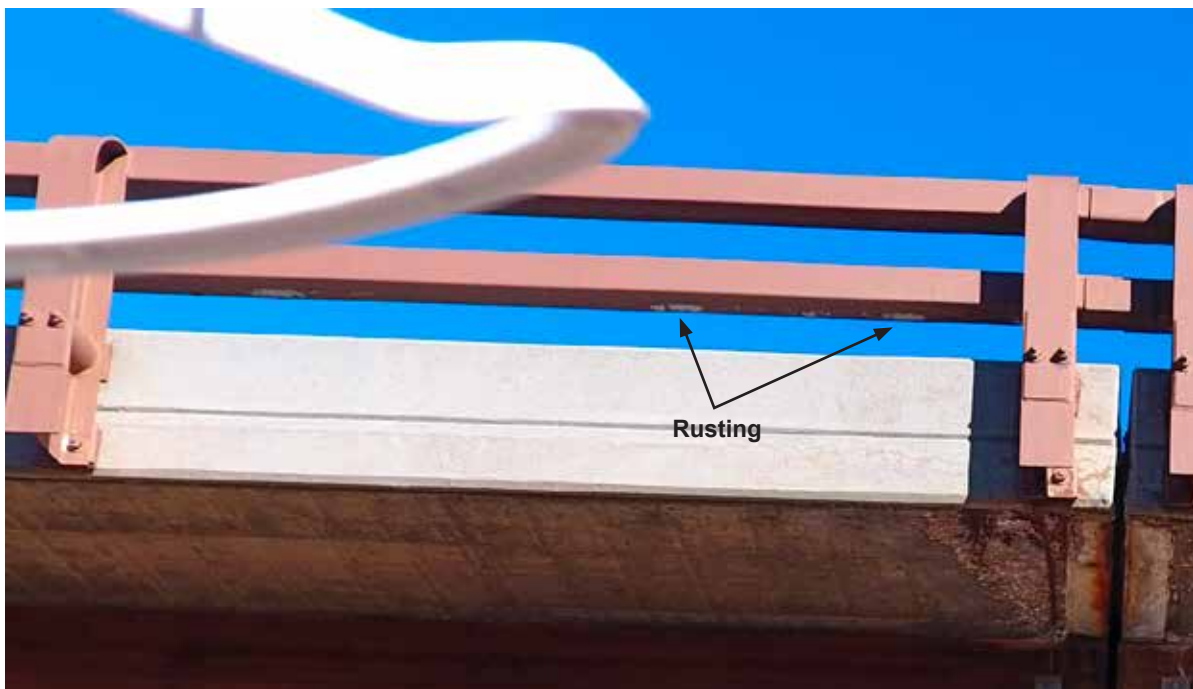
Figure 70. Sample damage on railing: (a) damage location; (b) mild rusting between Joints 4 and 5 near Stringer 1.
